Dakota Access, LLC
Dakota Access Pipeline Project- Pipeline Terminals
McKenzie, Mountrail and Williams Counties, ND
ND PSC Case No. PU-14-842
Keitu Project No. 569-1099

151 PU-14-842 Filed: 2/24/2016 Pages: 7
Update to topsoil segregation report

Site/Project Location: Epping Terminal

Date of Inspection: 4 February 2016

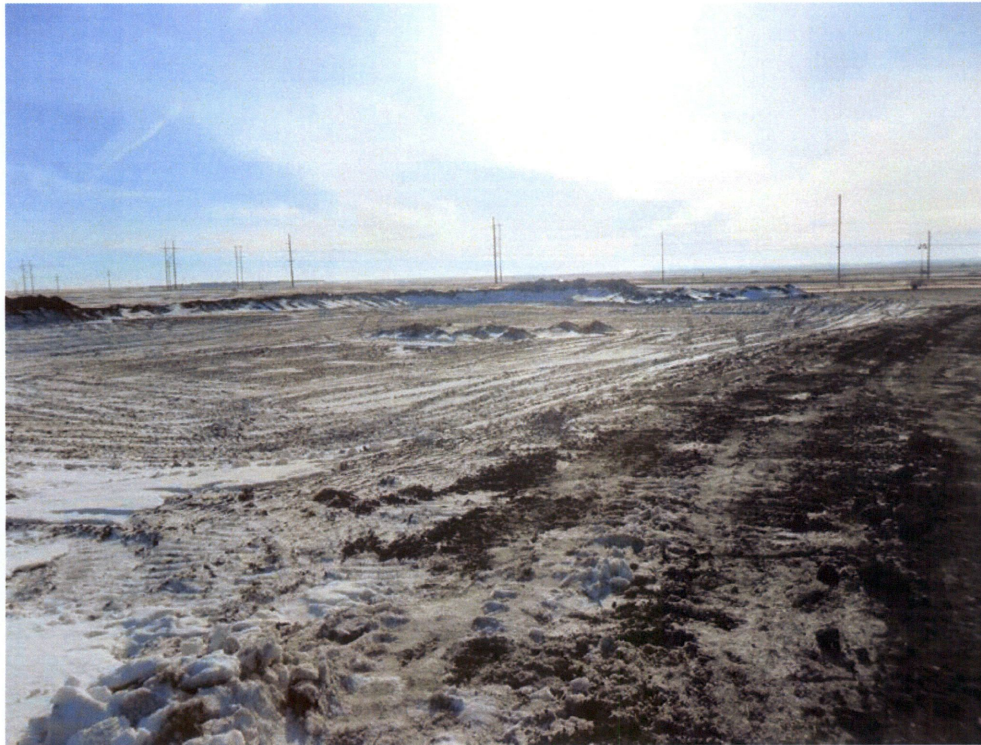
Some topsoil on east side of site was stripped already by previous site owner. Unable to determine whether previous site owner segregated topsoil from subsoil adequately. Depth of topsoil is roughly 10-inches on site. Storm water sediment control measures are in place along east and south borders of site.

Upon initial visit, previous site owner segregated topsoil from subsoil. Topsoil is piled on east side of site. Previous site owner also dug a 6-10 foot basin in the same area and piled the subsoil on southwest corner of site. Additional inspections will be needed to deem the topsoil was segregated adequately and whether the subsoil pile is on subsoil.

Report Photo #1 "Work from previous site owner" at GPS Coordinates: 48.285833°N 103.321667°W

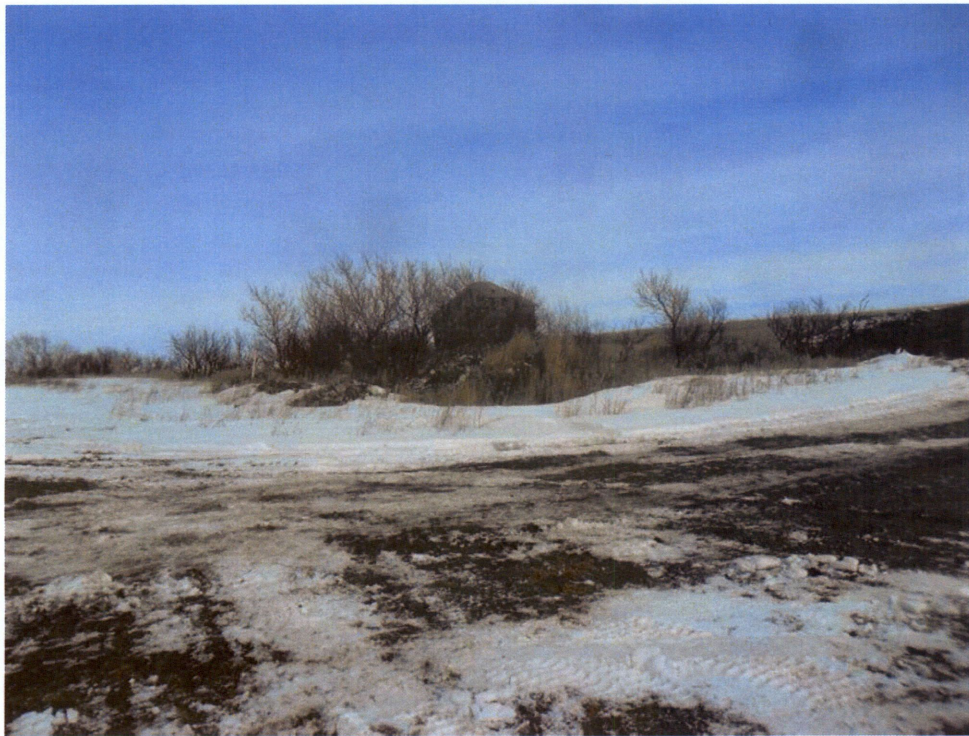
Tree row remains along north side of site, and one tree remains on northeast side of site. These trees have been surveyed and accounted for by as mentioned by Darren LeDouex of Matrix, Inc. No evidence of trees being removed currently.

Report Photo #2 "Tree shrub row on north side" at GPS Coordinates: 48.286667°N 103.322222°W

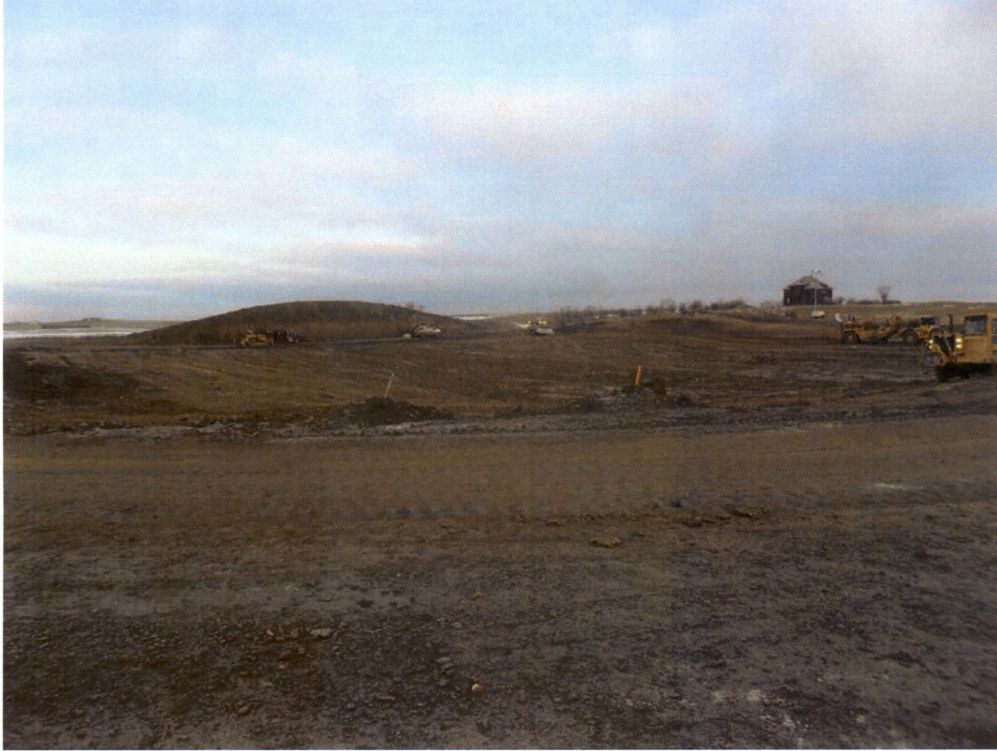
Stock piling stripped subsoil ground was underway by 3 earth movers and 2 dozers. Topsoil was stripped and stock-piled the previous night and early morning west of the subsoil piles. Topsoil and subsoil piles will be hauled off site per landowner request at unknown future date. Subsoil stripping and landscaping for future storage tanks continued during departure. Material and equipment staging still occurred at temporary laydown area on west side of site. Utility Inspection mentioned 15 acres will be used outside the property boundary on east side of site for equipment staging and offices.

Report Photo #1 “Stripped grounds being landscaped” at GPS Coordinates: 48.285278°N 103.321111°W

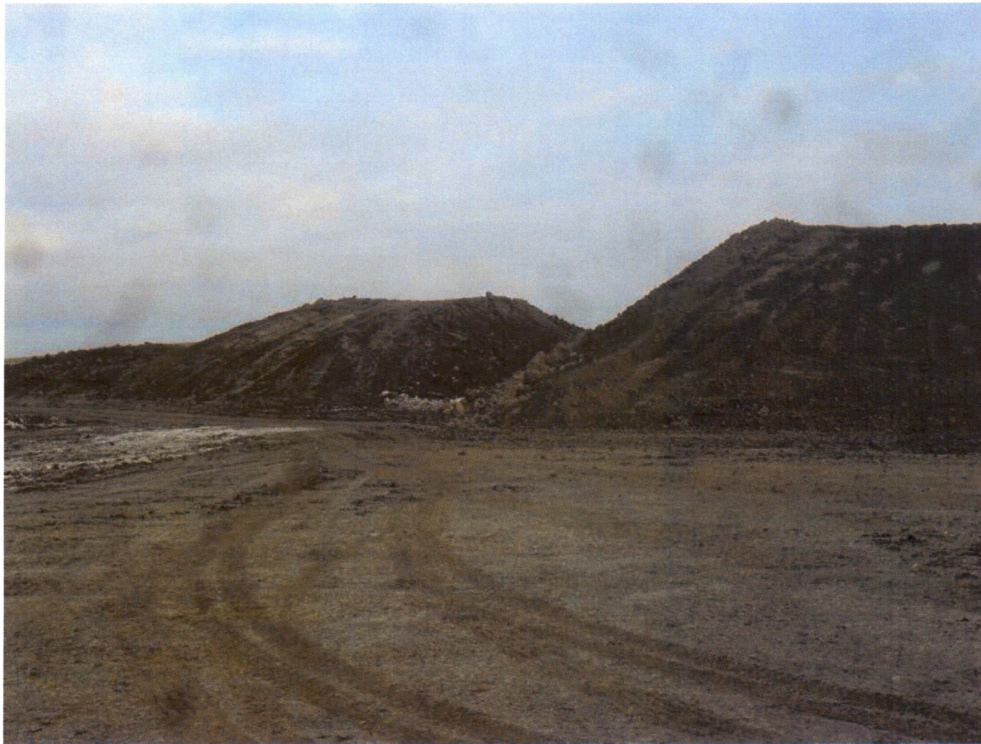
Roughly 1 foot of topsoil was stripped and stockpiled on west part of site during overnight hours. Topsoil from subsoil segregation appears adequate. Storm water sediment control measures are in place along east and south borders of site. Maintenance was being performed on the silt fences during site visit.

During site visit, Keitu inspector received confirmation that topsoil was stock piled on topsoil grounds. Subsoils piles were stockpiled on subsoils. Keitu inspector advised a scraper to be used when soils are hauled off site to prevent soils from being tracked off site.

Topsoil segregation proficiency by site operators was determined adequate.

Report Photo #2 “Topsoil pile left. Subsoil pile right” at GPS Coordinates: 48.285556°N 103.322778°W
